**Flood Control Project Maintenance
Levee Inspections**
LMA District Cover Sheet
Spring 2020 Levee Inspection Results

Reclamation District No. 2058 Pescadero

Levee Inspection Report By Mile - Spring 2020

Waterway	Bank	Unit Miles	Inspection Start/End	Inspector
Unit No. 01 Paradise Cut	Left	6.58	03/11/2020 03/11/2020	Alberto De Leon

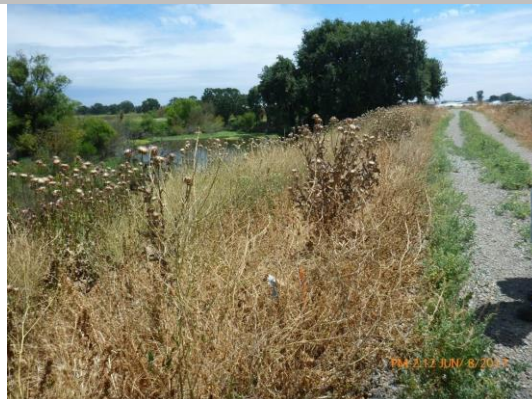
Photo 1 of 3 : LEVAL_SP_2020_100_1359.jpg

LM Start	4.77	Rating **	A/W	Issue No.	44	
LM End	4.77	Issue Type +	Ma	Location *	WS	
Category	Supplemental			GPS Latitude/Longitude		
				Start	End	
Item	2017 Storm Damage			37.785862 °		°
				-121.350303 °		°
DWR ID	DWR_RD2058_01_s_2020_44					
Comment Code						
Inspector Comment						
Plan for repair, term of agreement is through end date Dec. 31, 2020						
FSRP:Levee Evaluation Comments						
Description:						
Site ID No:100						
Site Designation:FSRP-14-25						
Repair Type: Erosion						
Rating:Area of Concern						
Field Date:6/8/2017						
Notes: vegetation too dense to evaluate damage. The erosion has about a 3 foot vertical cut at the waterside levee toe as of the Fall 2017 Inspection. Turned back over to Evaluators for re-assessment

LM Start	4.77	Rating **	A/W	Issue No.	44 (cont)
LM End	4.77	Issue Type +	Ma	Location *	WS
